Title	Technical report on commissioning of solar water heaters
Authors	Politecnico di Milano: Matteo Muscherà
Review	Politecnico di Milano: Marco Calderoni
Approved	Politecnico di Milano: Mario Motta
To	AMEE
Date of Report	11/07/2018
Document based on	<ul style="list-style-type: none">• 171018_Site-visit-SWH.pdf• AMEE tender documents
Deliverable number	D6

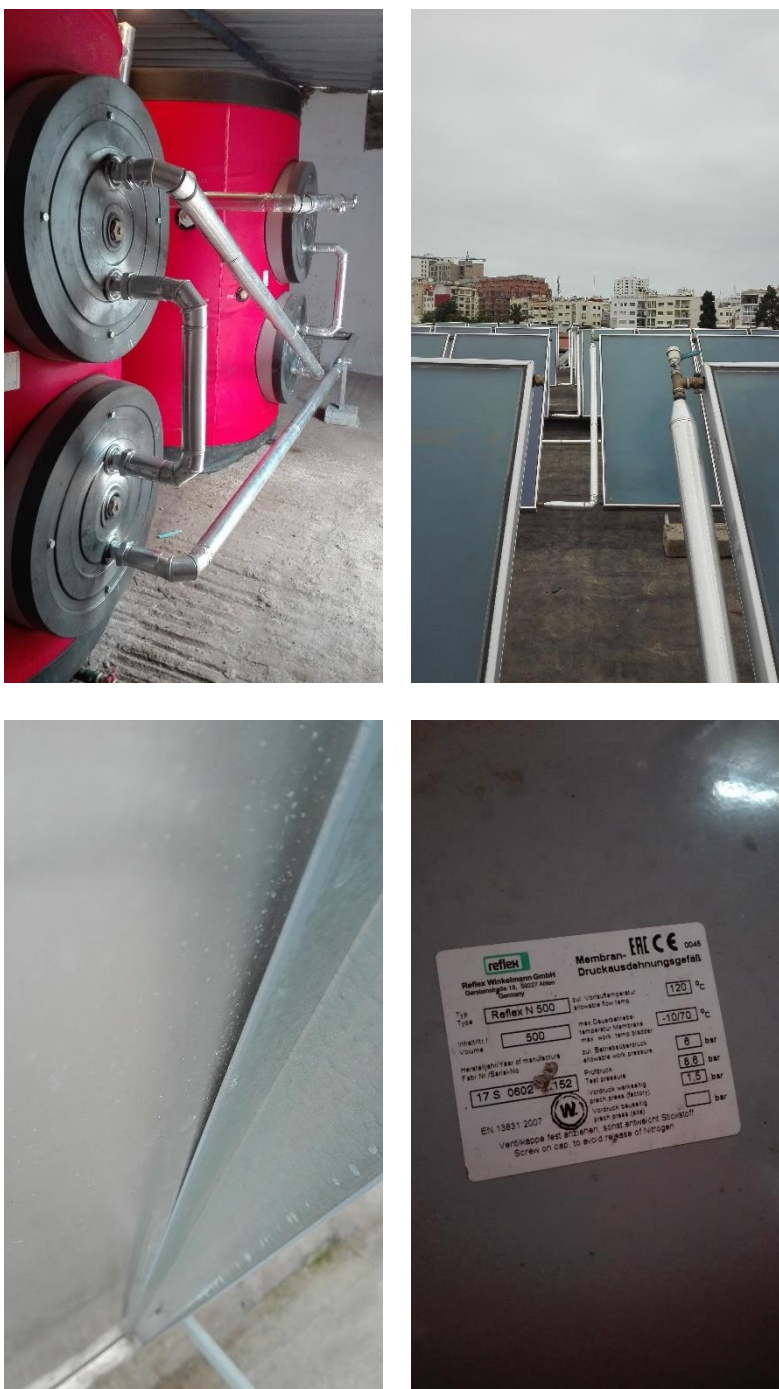
Figure 2.1: Pictures of adopted suggestions (Cuisine Centrale).

- the placement of the solar field has been changed, with the result of a regular pattern of solar collectors which facilitates a uniform flowrate in the whole solar field
- the suggested connection scheme (Tichlemann) has been adopted
- balancing valves have been removed
- radiator for heat dissipation has been removed
- double safety valve has been removed, and the correct connection of safety valve and expansion vessel has been adopted
- solar expansion vessel has been replaced with a bigger one as suggested
- connection of internal heat exchangers of storage tanks has been modified as suggested
- filling of the solar circuit is no more automatic, but the filling pump is manual, as suggested
- steel structure of solar collectors has been painted against corrosion

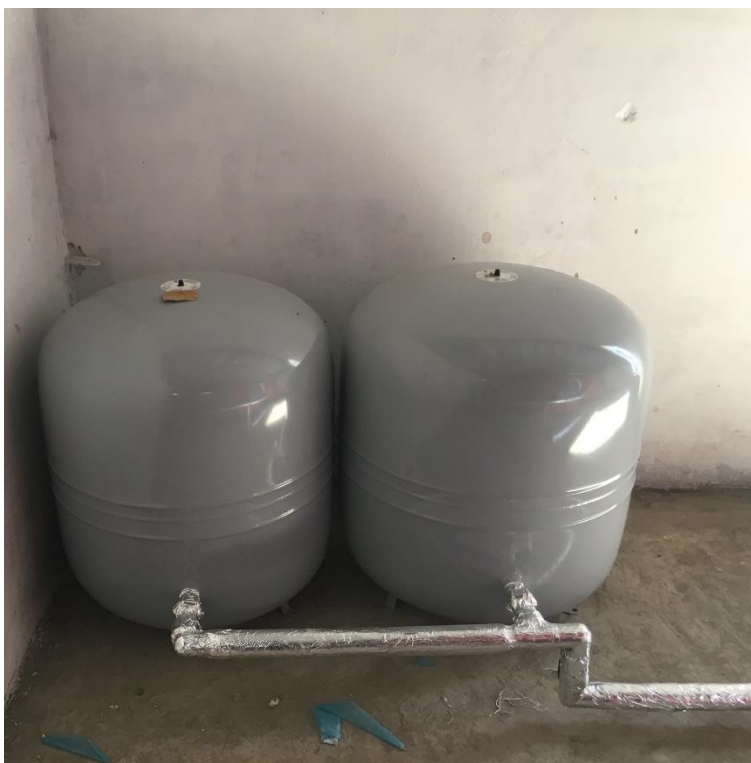
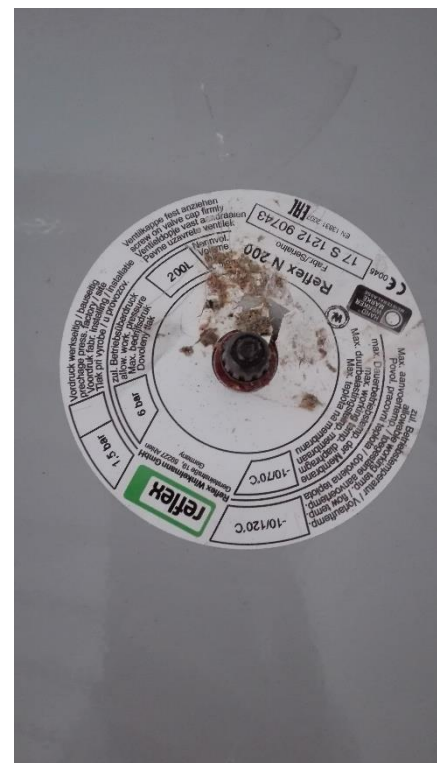
Figure 2.2: Cuisine Centrale expansion vessels, installed on domestic hot water side.

Lack of expansion vessels in domestic hot water circuit

Expansion vessel was installed only on solar circuit, while it is necessary also on domestic hot water side. Minimum volume is $6000 \text{ l} \cdot 0.06 = 360 \text{ l}$, the installer immediately provided and installed two expansion vessels of 200 l each, thus a global volume of 400 l.

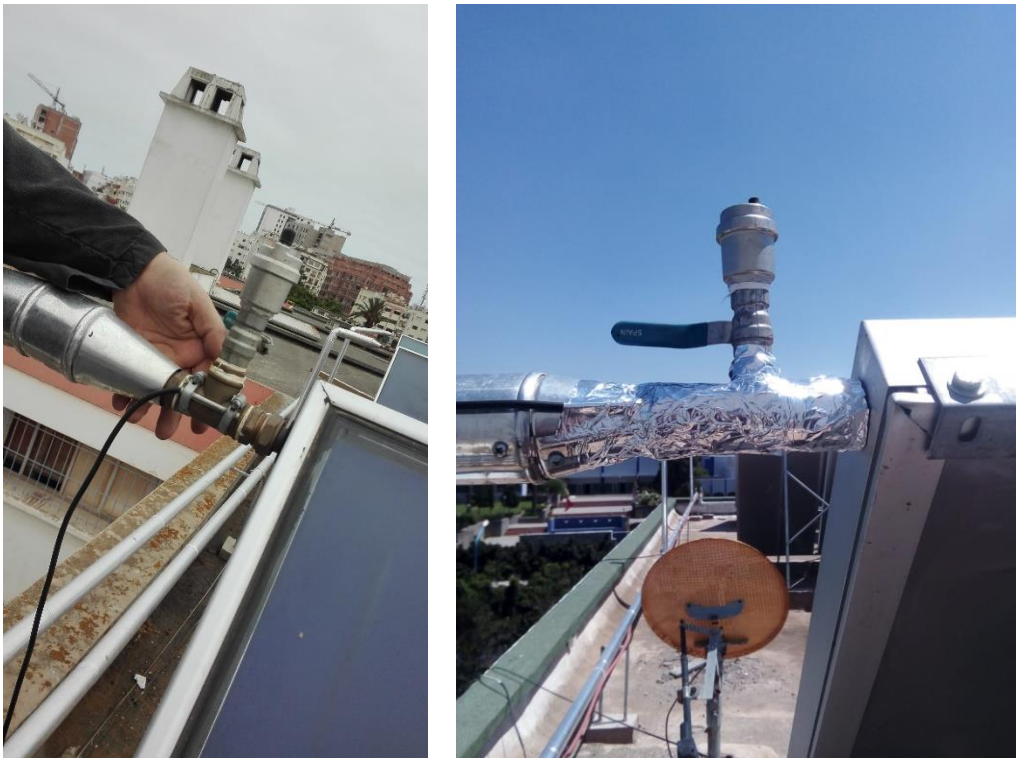
Figure 2.4: Cuisine Centrale S1 sensor.

Temperature sensor S1 installation

The temperature sensor S1 is used to monitor the solar field temperature. The probe was not well installed, as it was not insulated. This causes a bad control of the plant (pump and bypass valve), as the sensor does not feel the real temperature of the solar fluid, but the measure is an average between solar fluid and ambient/sky temperature. The installer solved the issue insulating and protecting the sensor S1.

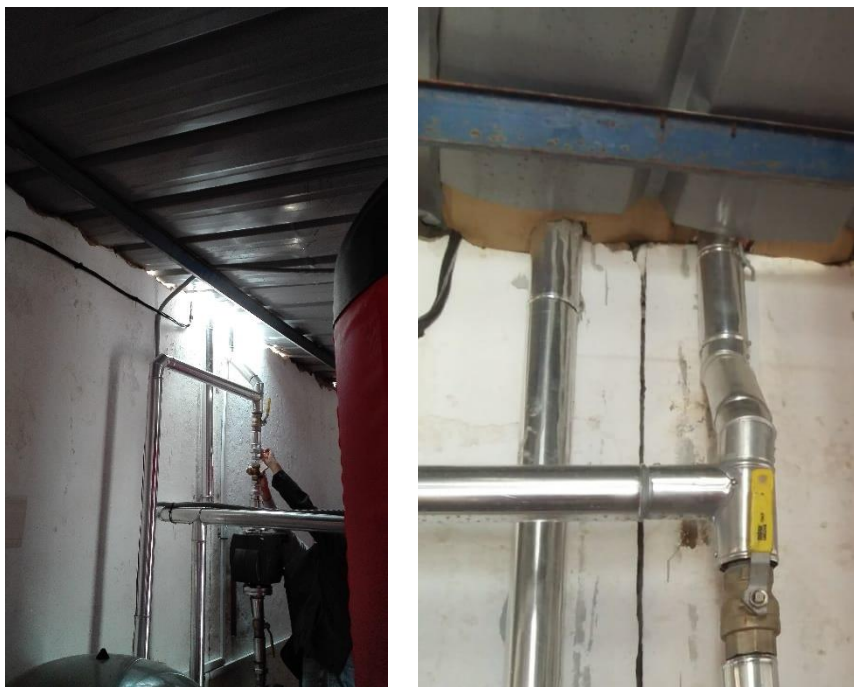
Figure 2.5: Cuisine Centrale technical room.

Roof of technical room

The installer had to build a technical room to protect storages, pump, valves, safety components and electrical devices. The roof of this technical room was not finalized. The installer finalized the construction of the roof during the on-site visit.

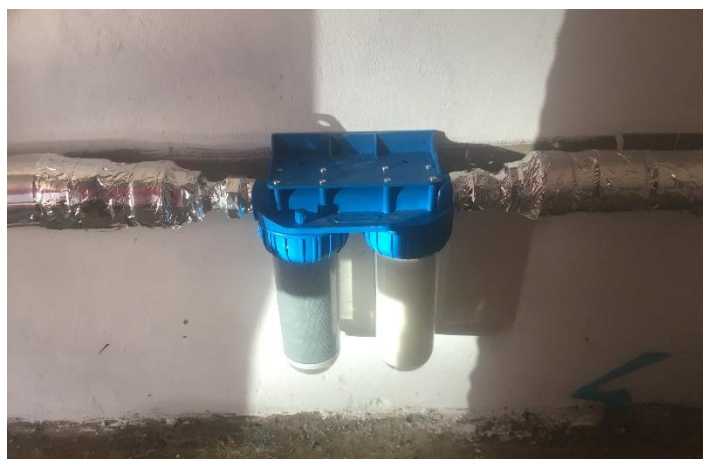
Figure 2.7: Cuisine Centrale additional filters.

Additional filters to be installed

As reported in the tender, two additional filters must be installed, one physical and one chemical filter. The installer purchased and placed one wool-filter (physical) and one carbon filter (chemical).

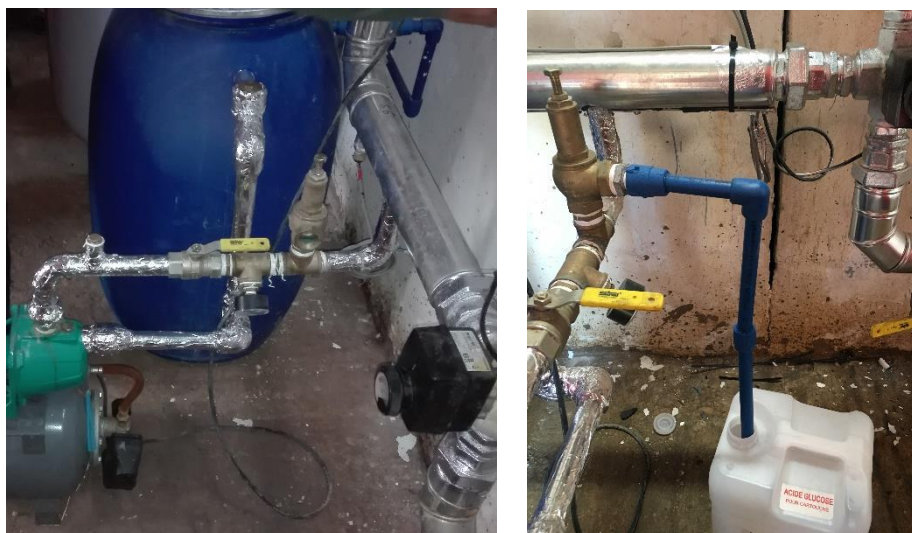
Figure 2.8: Cuisine Centrale collection system for solar safety valve..

Collection system for solar safety valve

It is necessary to install a pipe and a tank at the outlet of security valve to collect solar fluid that potentially comes out in case of overpressure. The installer solved the issue immediately.

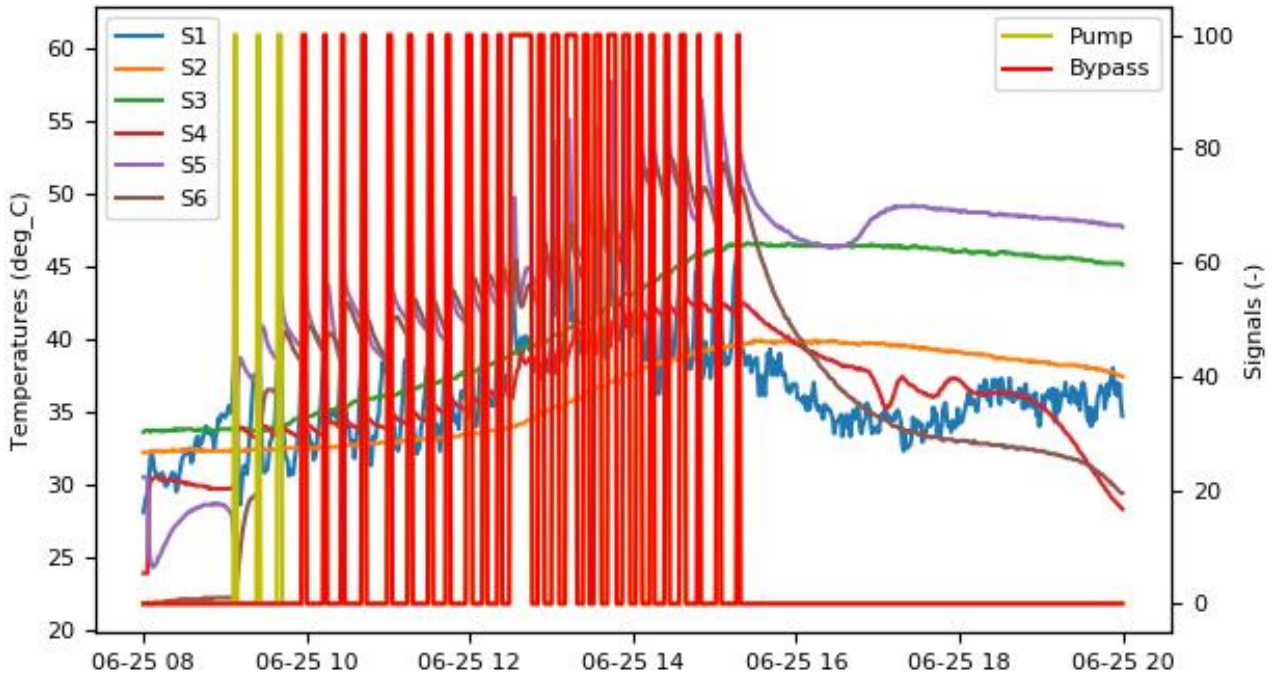
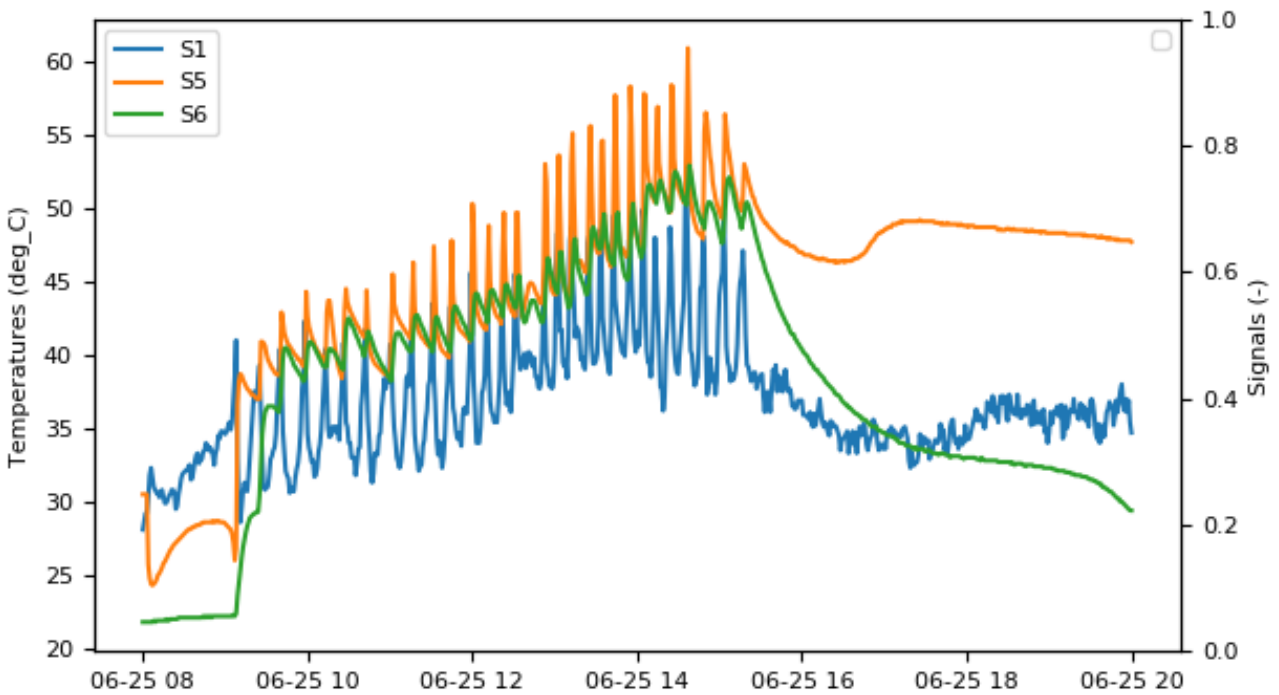
During the last on-site visit, these data have been analysed to check the plant operations. During the first day (June 25th), the pump activation was very irregular, as a continuous on-off cycle affected pump and bypass operation.

- Wrong position of sensor S6 (refer to issue #2): the sensor has been placed on the bypass pipe, while the right position is on the supply pipe (as illustrated in Figure 2.9). This causes a continuous on-off cycle of the bypass three-way valve.
- Bad installation of sensor S1 (refer to issue #3): the sensor has not been insulated, thus the acquired temperature of solar collectors was not the real one. As a matter of fact, S5 and S6 temperatures was always higher than S1, while in normal conditions should be the opposite.

Figure 2.10: Cuisine Centrale plant operation in June 25th.

Figure 2.11: Cuisine Centrale plant operation in June 25th, detail of solar loop temperatures.

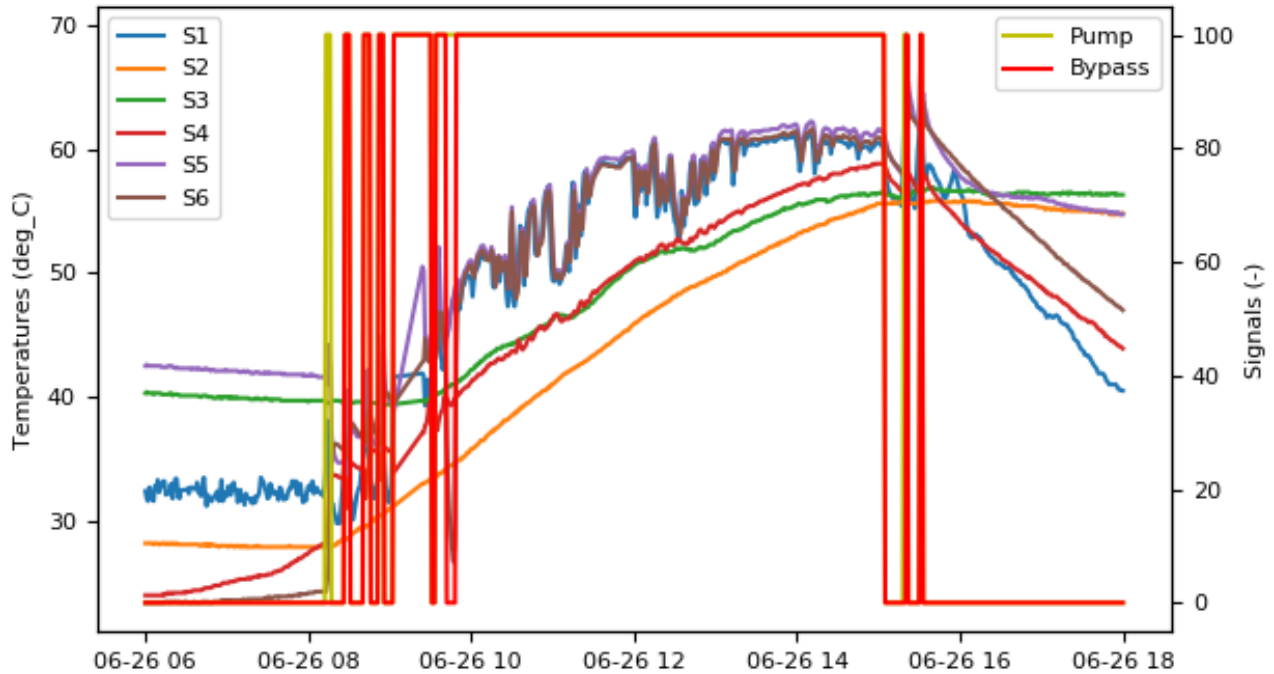
Figure 2.12: Cuisine Centrale plant operation in June 26th.

After the solution of these issues, plant operations can be considered acceptable.

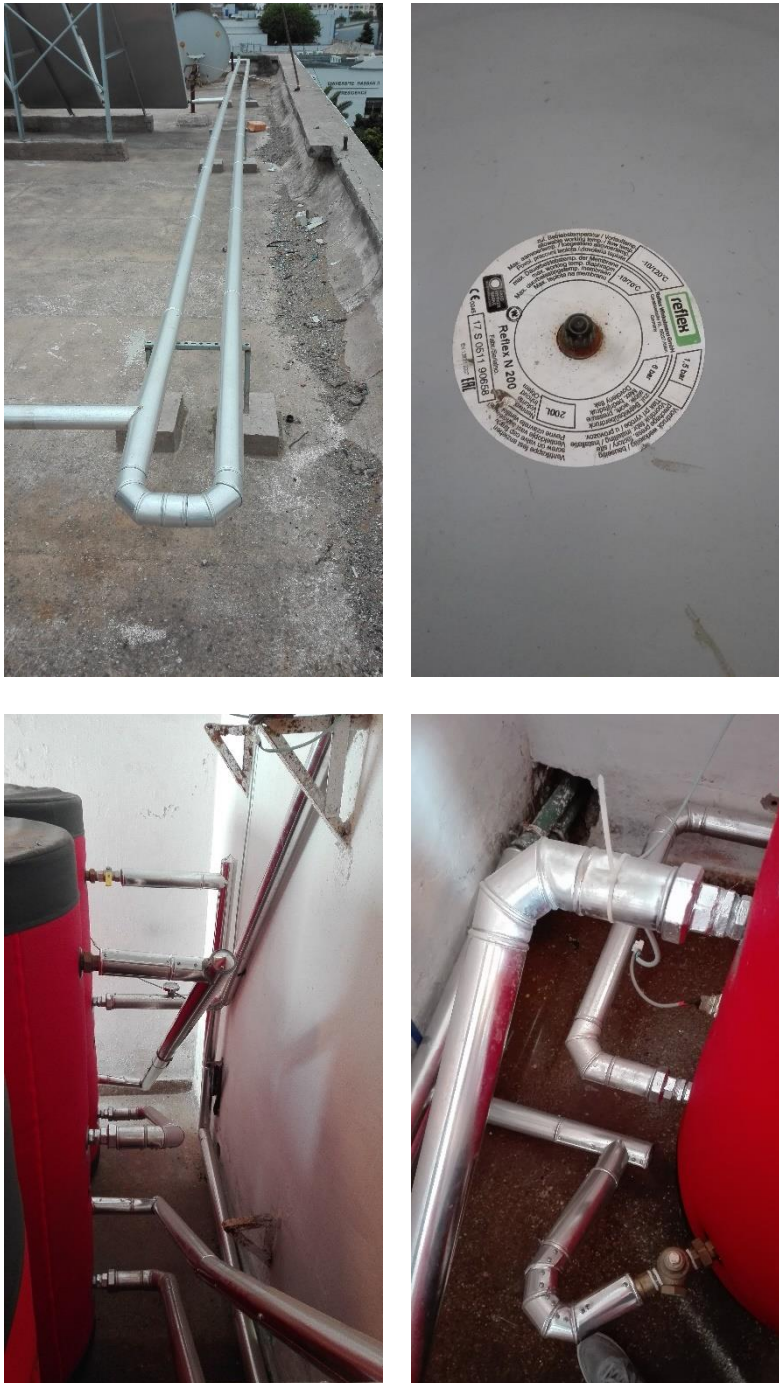
Figure 3.1: Pictures of adopted suggestions (Internat Faidouzi).

Generally, all remarks and comments raised during the October 2017 on-site visit have been accepted by the installer. These remarks are the same of “Cuisine Centrale” plant, except for the collector field placement, which in this case was already acceptable.

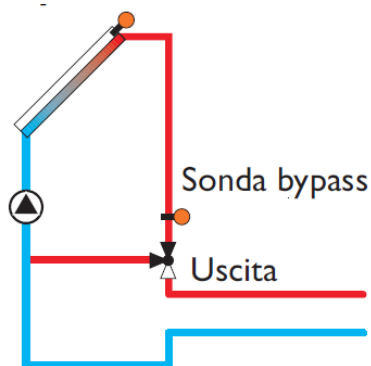
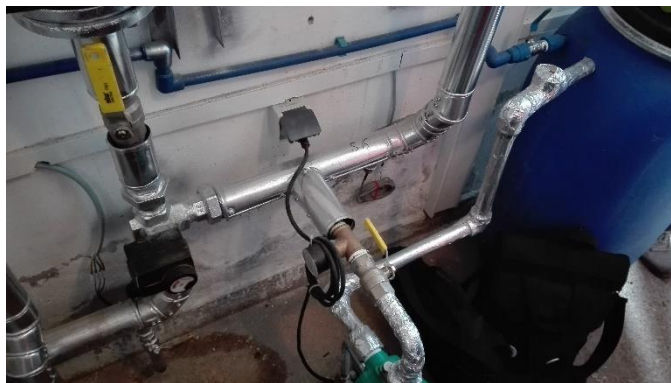
Figure 3.3: Internat Faidouzi, position of sensor S6 for bypass valve control.

Wrong position of sensor S6

The temperature sensor S6 was placed on the bypass pipe, while should be placed on the supply pipe, as illustrated in the RESOL scheme. The installer solved the issue placing the sensor in the right position.

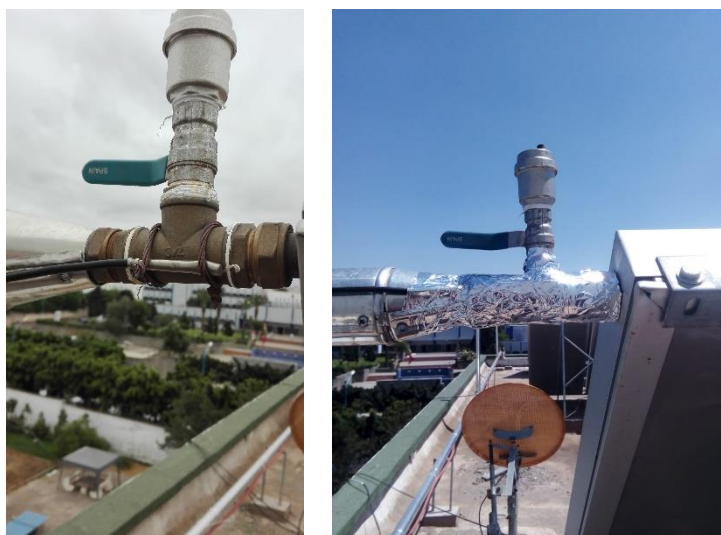
Figure 3.4: Internat Faidouzi S1 sensor.

Temperature sensor S1 installation

The temperature sensor S1 was not well installed, as it was not insulated. The installer solved the issue insulating and protecting the sensor S1.

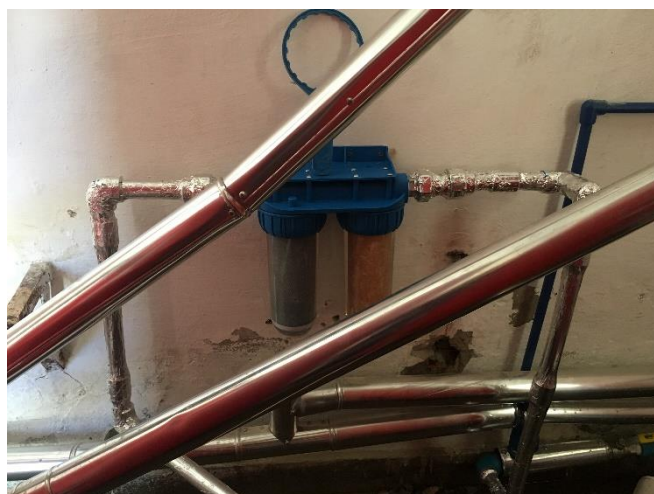
Figure 3.5: Internat Faidouzi additional filters.

Additional filters to be installed

As reported in the tender, two additional filters must be installed, one physical and one chemical filter. The installer purchased and placed one wool-filter (physical) and one carbon filter (chemical).

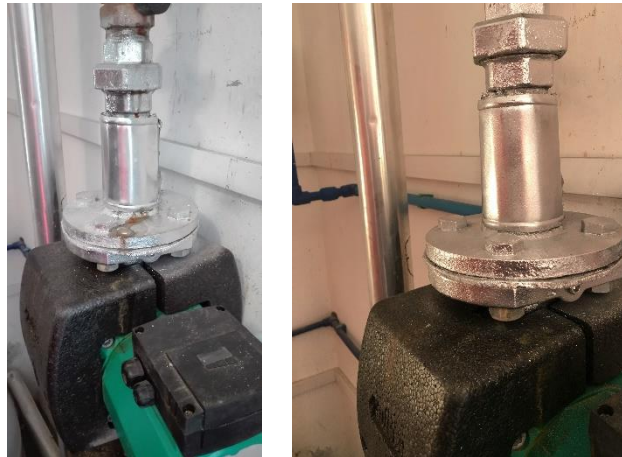
Figure 3.8: Internat Faidouzi solar pump.

Glycol leakage from solar pump

During the visit a small glycol leakage was detected. The installer solved the problem cleaning and tightening the connection of the pump.

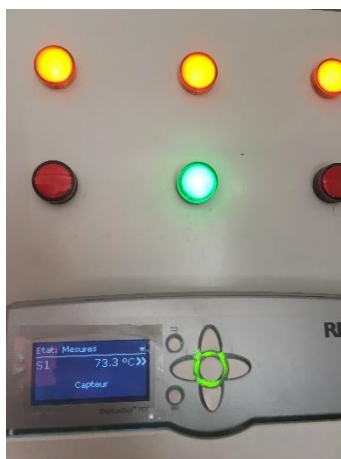
Figure 3.10: Internat Faidouzi electrical panel.

Pump light in electric panel

In the electric panel has been installed a green light useful to see if the pump is active or not. During the site visit this light was out of order. The installer solved the problem replacing the light bulb.

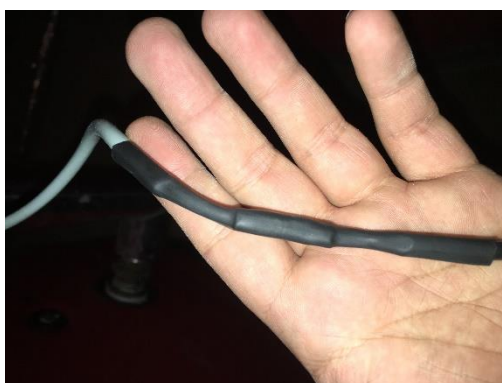
Figure 3.11: Protection of electrical connections.

Unprotected sensors wire connections

All electrical connections must be protected from water, especially electrical connections installed outdoor. The installer solved the problem with a thermo-plastic membrane.

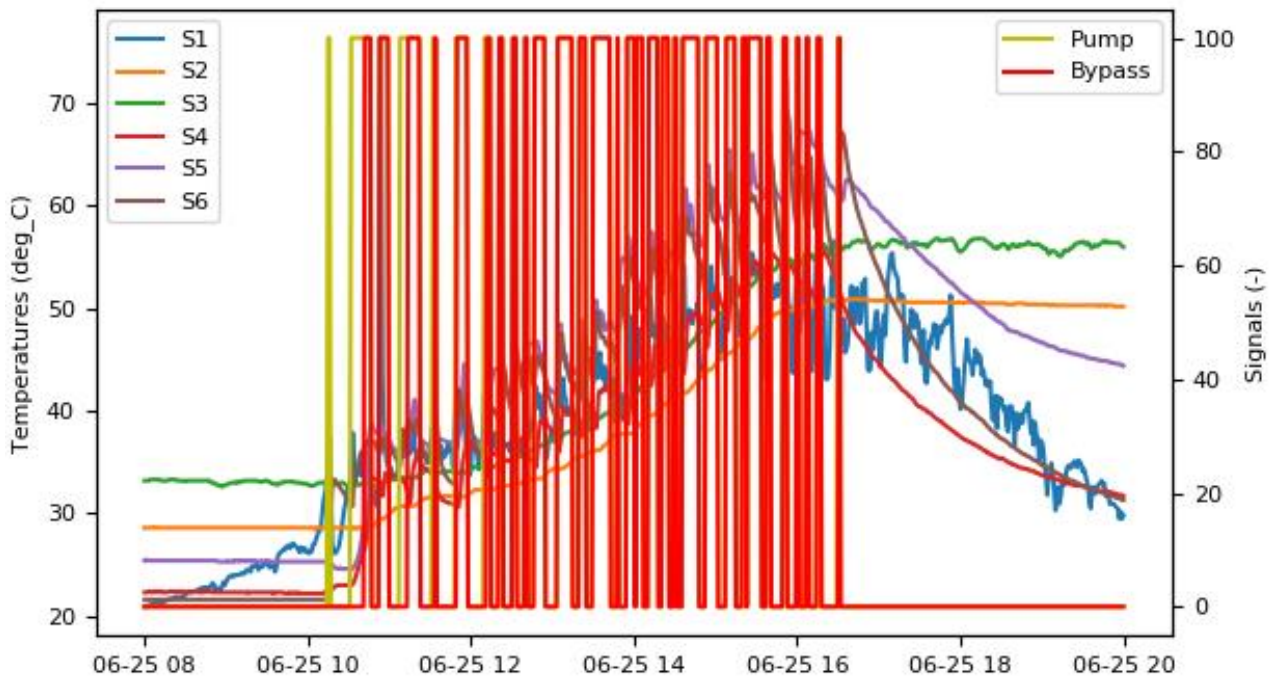
Figure 3.12: Internat Faidouzi plant operation in June 25th.

Detected problems are the same of “Cuisine Centrale” plant, as installation issues are quite the same. During June 25th operations, there is an on-off cycle of pump and valve, caused by sensor S6 wrong position and S1 bad installation.

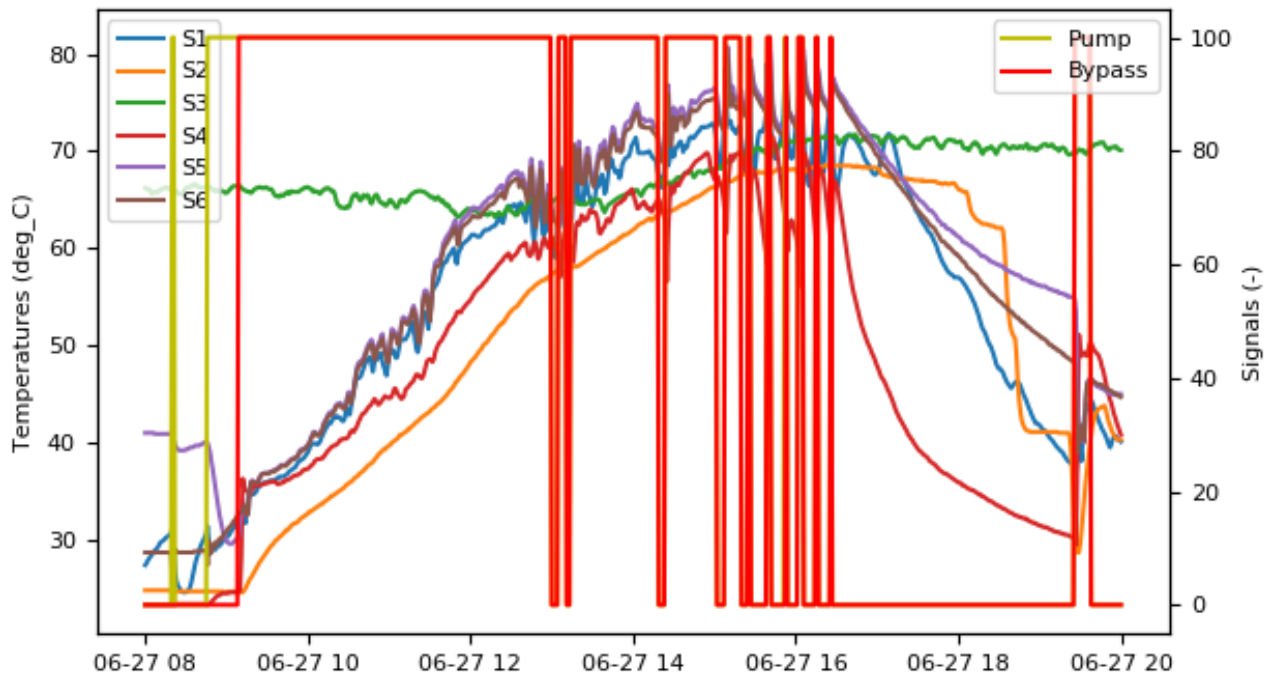
Figure 3.13: Internat Faidouzi plant operation in June 25th.

After the solution of discussed issues, the operation can be considered acceptable. In this case, the temperature difference between S1 and S5 (or S6) is not ideal, as acquired collectors temperature is still lower than supply pipe temperatures. The suggestion is to frequently check plant operations, and if necessary to improve the insulation and protection of S1 sensor.

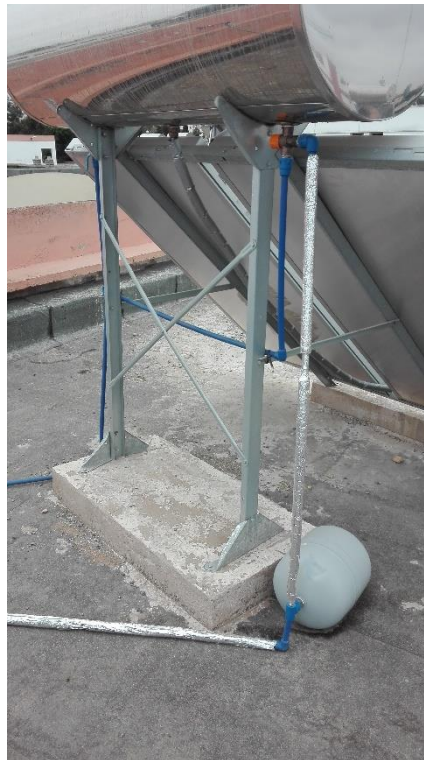
Figure 4.1: Domestic water pipes installation.

Domestic water pipes installation

Particular attention should be paid to pipes installation, regarding thermal expansion of materials. Some connections are too tightly fixed, and others are directly placed on the floor, preventing the natural expansion of pipes. This could cause the distortion of pipes, that might in some cases result in leakages.

It was not possible during the on-site visit to check all installations; thus, the suggestion is to monitor frequently the situation, possibly fixing worst cases of pipes distortion.

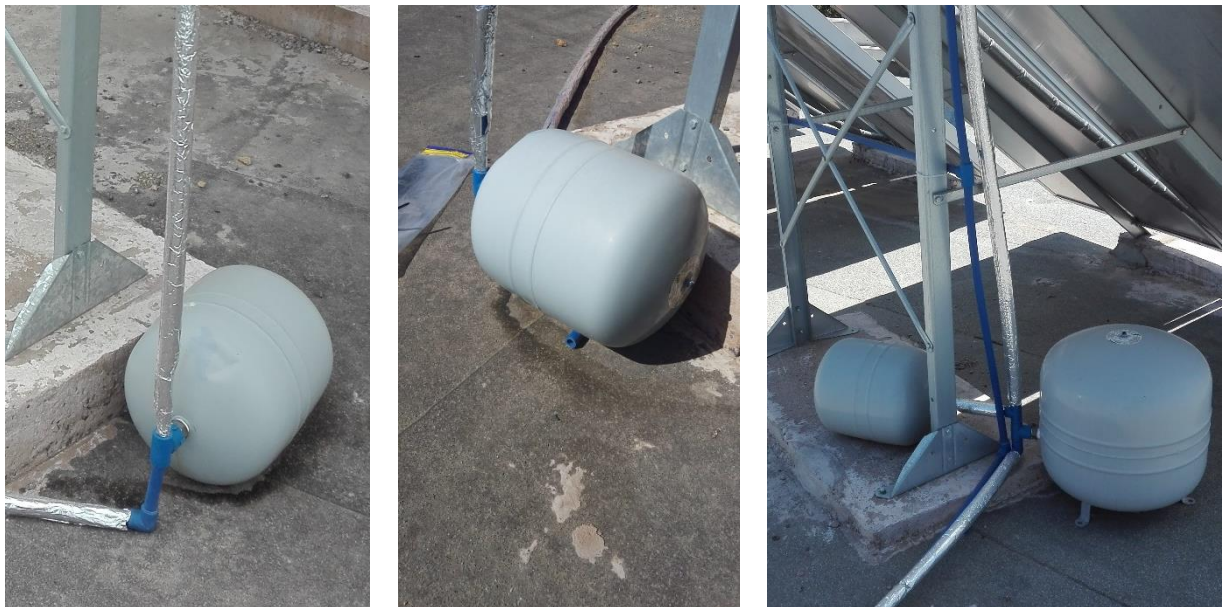
Figure 4.2: Expansion vessels placement.

Expansion vessels placement

Some expansion vessels on domestic water side have been installed horizontally (expansion vessels without feet). The direct contact with the floor could cause corrosion of the external surface of the vessel if the roof draining is not perfect. When possible, expansion vessels should be placed on the concrete basement of the solar collector structure. If not possible, at least the expansion vessel should be risen. The installer solved with some plastic pipe pieces used to rise expansion vessels from the floor.

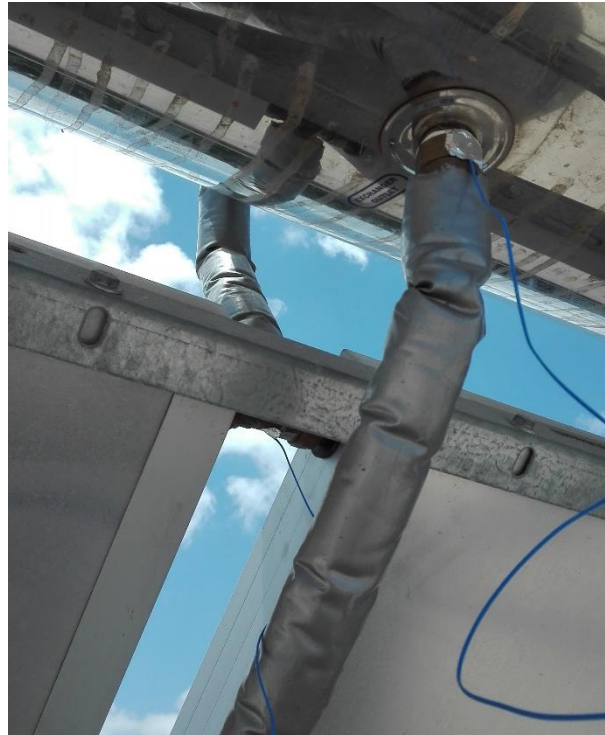
Figure 4.3: Thermocouple placement during natural circulation system check.

Natural circulation plants are not equipped with a control unit, as there are no pumps or valves to operate. To check qualitatively the operation of a sample collector, a thermocouple reader has been used, to evaluate the temperature difference between inlet and outlet of solar collector.

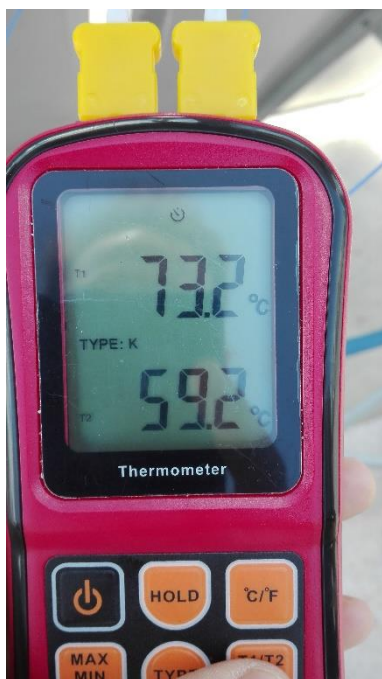
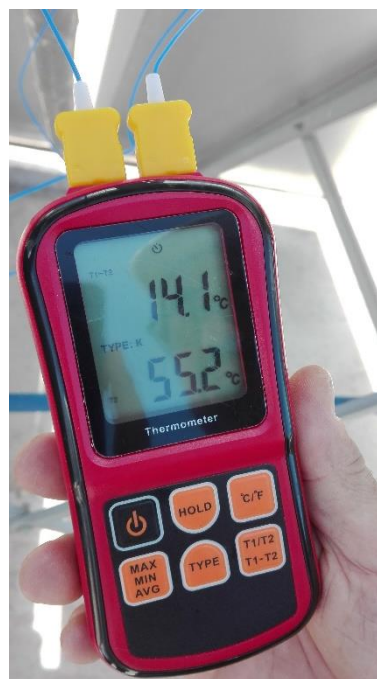
The measure has been performed in a sunny condition and in a cloudy condition, with results illustrated in following figures.

Figure 4.4: Temperatures reading during sunny condition in two different moments. Left: higher and lower temperatures. Right: delta-T and lower temperature.

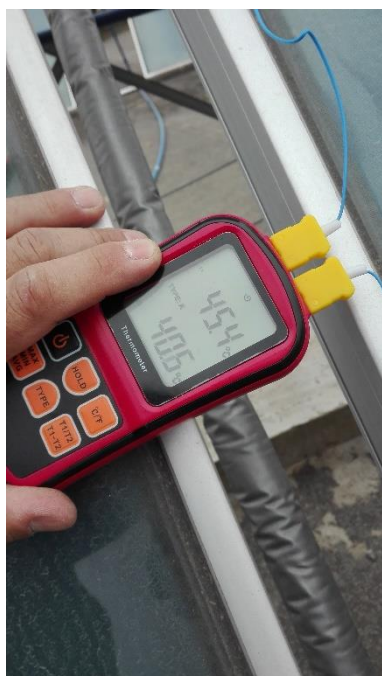
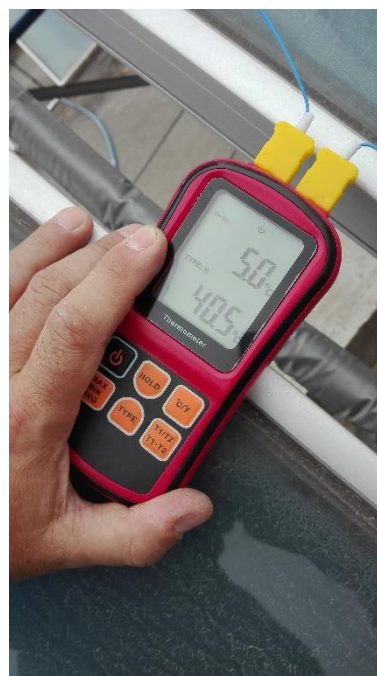
Figure 4.5: Temperatures reading during cloudy condition in two different moments. Left: higher and lower temperatures. Right: delta-T and lower temperature.

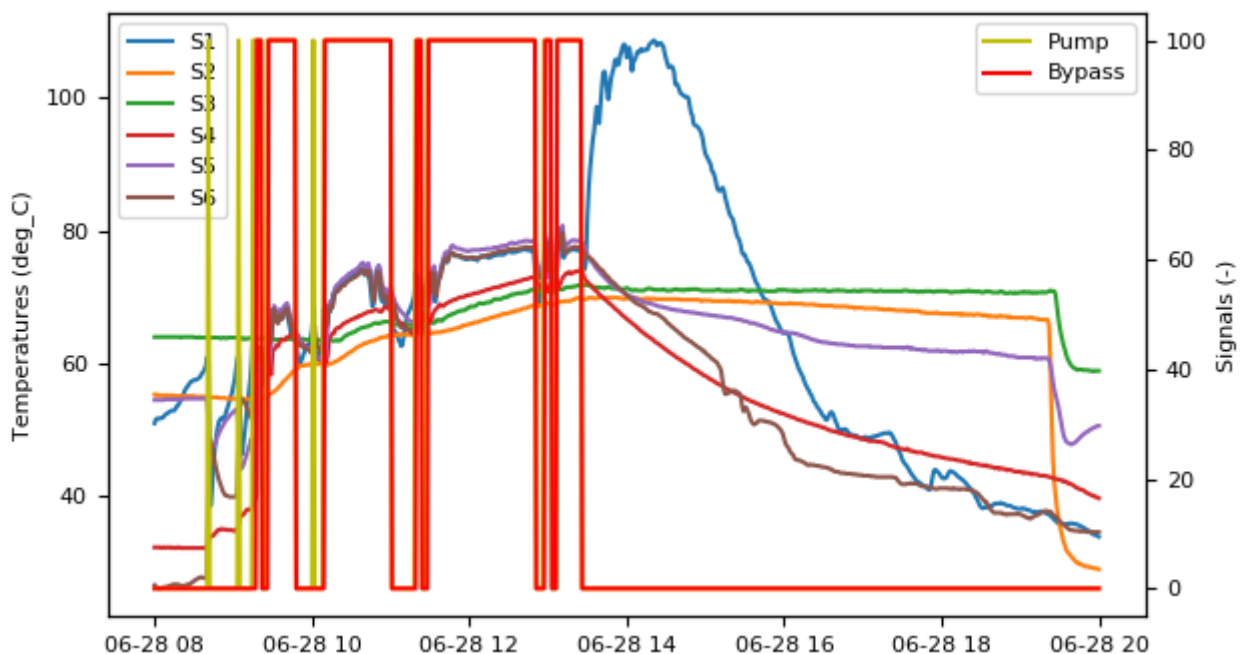
Figure 5.1: Stagnation condition of Cuisine Centrale plant on June 28th.

Finally, a very important comment must be done regarding domestic water plants of hospital buildings. Now that all solar plants are operative, not all users are in good conditions. E.g., both for Cuisine Centrale and for Internat Faidouzi, the expected users are not connected to the solar storage. The result is that the solar plant will be most of time in overheating condition (stagnation).

The same situation has been detected for some natural circulation solar plants. We strongly suggest pushing hospital technicians and managers to fix all problems related to hydraulic circuit supplied with solar energy. In addition to wasting the possibility to have hot water for hospital patients, this is a risk for solar plants lifetime, which could be sensibly reduced due to constant stagnation condition.
